Observations on retrieved humeral polyethylene components from reverse total shoulder arthroplasty

Denis Nam, MD^{a,*}, Christopher K. Kepler, MD^a, Shane J. Nho, MD^a,
Edward V. Craig, MD^a, Russell F. Warren, MD^a, Timothy M. Wright, PhD^b

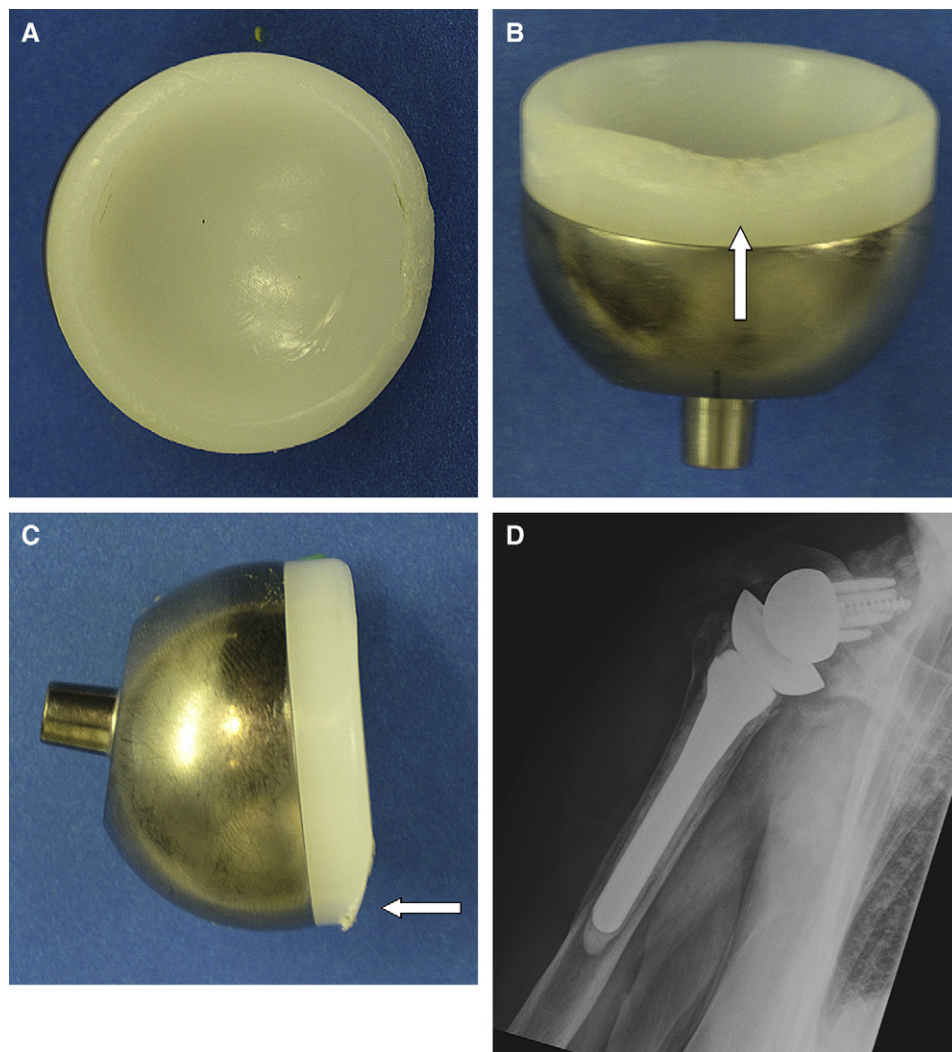
Scratching was the most common damage mode, present on all 14 components, closely followed by abrasion, present in 13 components (Fig 5, A-D). Scratching was noted in each quadrant in all 14 components, with no significant difference in overall severity among regions. In contrast, abrasive wear was most prevalent and severe in the inferior quadrant ($P = .02$). Abrasion was appreciated in both the articular surface and the extraarticular region of the polyethylene as it contacted the lateral edge of the scapula, and both these regions were considered when calculating the damage score. Embedded third-body debris and pitting were seen in 8 and 6 components, respectively, consistent with metallic debris generated from the glenosphere or metaglene components. Burnishing was present in 4 polyethylene components, surface deformation in 3, and both fracture and focal wear were each found once in a single component in which the glenosphere had eroded and fractured the inferior aspect of the humeral polyethylene. Delamination was not found in any of the retrieved components.

Figure 5 (A) Humeral polyethylene demonstrates scratching and pitting consistent with adhesive surface wear. (B, C) Humeral polyethylene demonstrates abrasive wear in the inferior quadrant consistent with a clinical adduction deficit (D). Anteroposterior radiograph of the implant shown in Panels B and C is consistent with scapular notching.

Our analysis found no association between scapular notching and glenosphere positioning, or between scapular notching and overall polyethylene wear scores, but a positive correlation was present with inferior quadrant surface deformation ($r = 0.66$). The relationship between scapular notching, functional outcomes, and polyethylene wear has not been elucidated, but descriptions of this problem have led to implant design changes such as inferior placement of the glenosphere, increased inferior glenosphere tilt, and lateralization of the center of rotation, although this raises concerns of increased shear stress at the bone-implant interface.^{20,30} In our analysis, 59% of the radiographs available for Depuy components demonstrated notching vs 20% of the radiographs available for Encore, although no significant difference in overall polyethylene wear or inferior quadrant wear was appreciated. The single, Encore implant that demonstrated scapular notching on preoperative radiographs had significant humeral polyethylene inferior abrasive wear (Fig. 5, B-D).

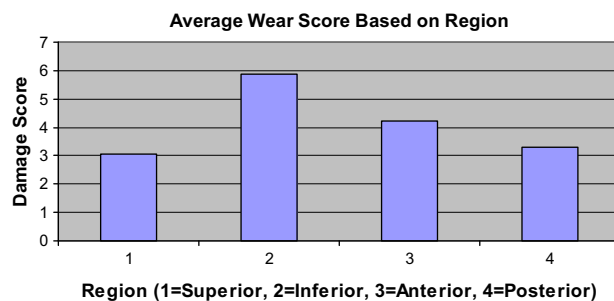
Irrespective of damage mode, the inferior quadrant suffered the greatest amount of wear damage, with a mean total score of 5.9, followed by the anterior (4.2), posterior

(3.3), and superior (3.1) regions (Fig. 6). The difference between inferior and anterior wear was significant ($P = .02$), indicating that the inferior quadrant was subjected to the greatest amount of cumulative wear. Abrasion was the only damage mode that was seen in multiple polyethylene components that also demonstrated a significant difference among the 4 regions because the inferior quadrant suffered greater abrasive wear than the other 3 ($P = .02$).

Figure 6 Graph demonstrates the regional damage score, regardless of mechanism.

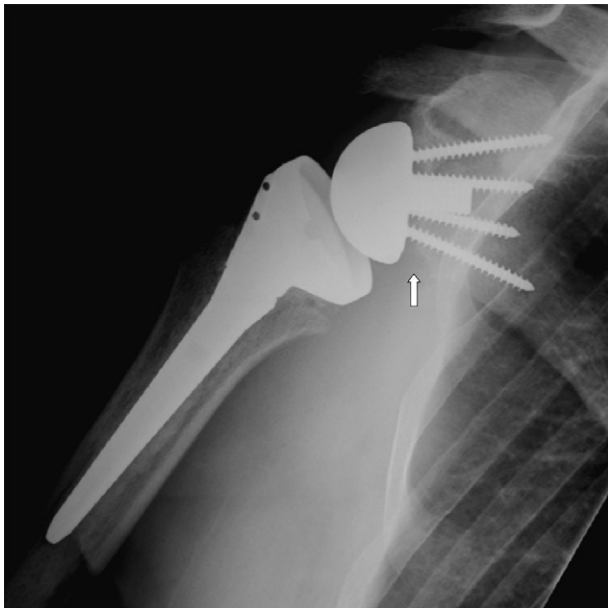
Figure 7 Radiograph demonstrates severe scapular notching.
