## Observations on retrieved glenoid components from total shoulder arthroplasty

Shane J. Nho, MD, MS<sup>a</sup>, Denis Nam, MD<sup>a,\*</sup>, Owen L. Ala, MD<sup>b</sup>,  
Edward V. Craig, MD<sup>a</sup>, Russell F. Warren, MD<sup>a</sup>, Timothy M. Wright, PhD<sup>b</sup>

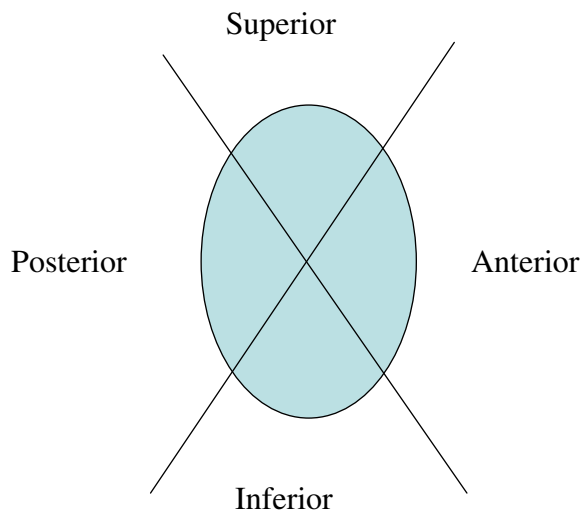
Grade	Percent of Damage
0	No Damage
1	1%-10% Damage
2	11%-50% Damage
3	51-100% Damage

\*Severe damage in a small area increases score by one point.

**Figure 1** Damage map and score<sup>a</sup> for glenoid components.

The polyethylene-bearing surfaces of the components were examined microscopically using  $\times 31$  magnification in a light stereomicroscope. For each surface, 9 modes of damage were subjectively scored: burnishing, abrasion, scratching, pitting, delamination, focal wear, surface deformation, embedded third body debris, and fracture, based on previously developed scoring systems for polyethylene joint replacement components.<sup>10,11</sup> The surface was divided into anterior, posterior, superior, and inferior quadrants and given a subjective damage score of 0 to 3 for each damage mode in each quadrant<sup>10</sup> (Figure 1).

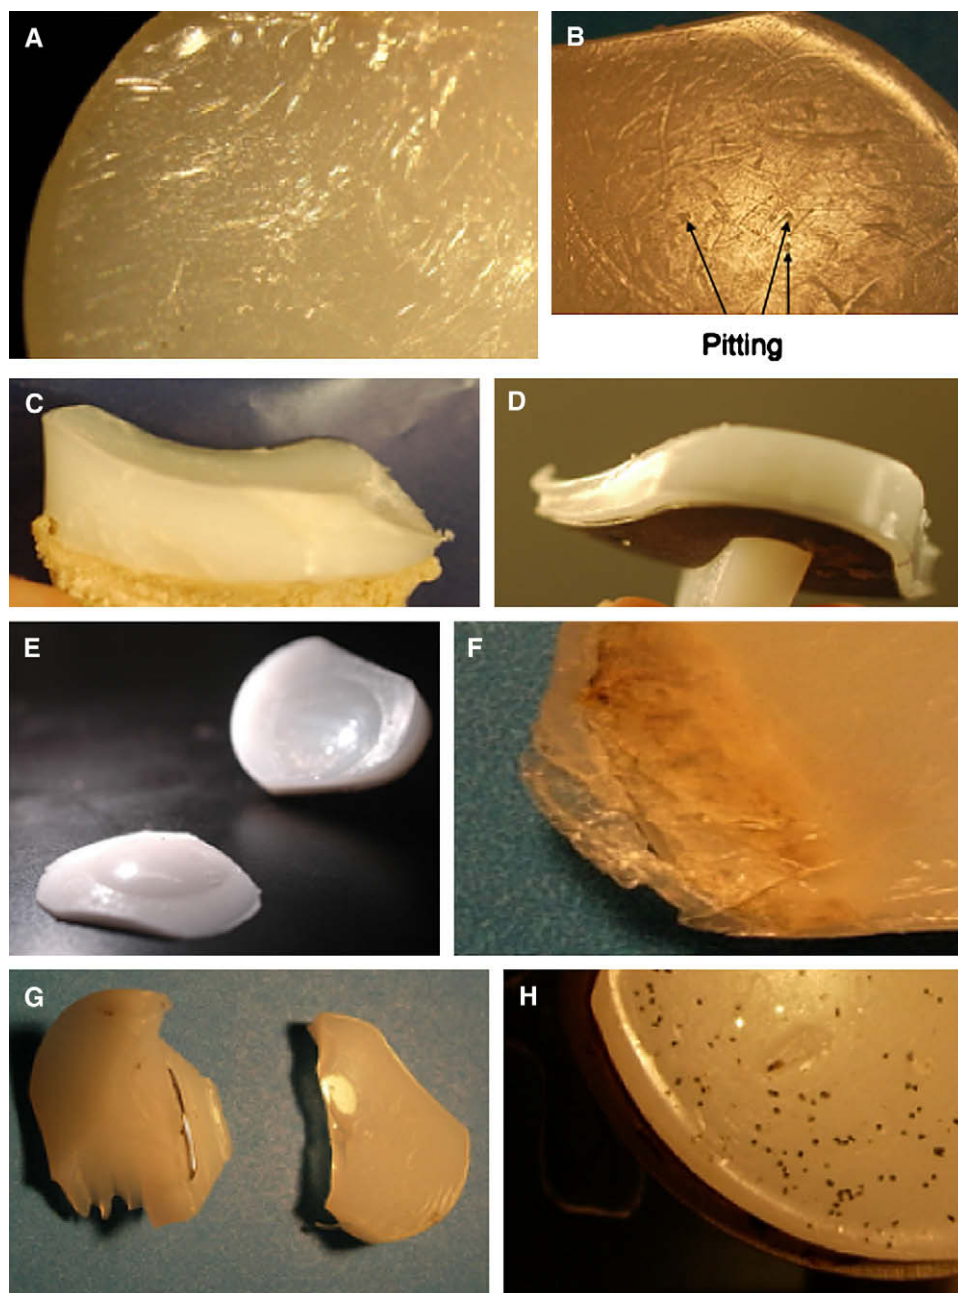
**Figure 2** (A) Scratching was present in 78 glenoids retrieved. (B) Pitting was present in 73. (C) Abrasion on the edge of the component, consistent with glenoid impingement with the humerus, was evident in 29 components. (D) Edge deformation evident in 18. (E) A focal wear damage pattern was present in 7 components with nonconforming designs. (F) Delamination was noted in 10 glenoids, consistent with a fatigue wear mechanism. (G) Fractures were present in 7 components. (H) Third body metallic debris was found in the 4 glenoids with metal backing fixed with screws.

Scratching was the most common damage mode, involving all 78 glenoids that were retrieved, closely followed by pitting in 73 glenoids (Figure 2, A and B). Both modes were most prevalent on the inferior aspect of the retrieved components. Next were burnishing in 54 glenoids and abrasion in 53 (Figure 2, A and C). Specifically, abrasion on the edge of the component, consistent with glenoid impingement with the humerus, was evident in 29 of 78 glenoid components (Figure 2, C). In two-thirds of these cases, the abraded area occurred on the anterior and inferior quadrants. Surface deformation occurred in 48 of the retrieved glenoids, with edge deformation evident in 18

(Figure 2, D). In 63% of the glenoids with deformed edges, the deformation occurred on the posterior quadrant.

Wear-through occurred in 32 glenoids, with a focal wear damage pattern in 7 of these components, all with nonconforming designs, in which a new bearing surface similar to the radius of curvature of the opposing humeral component was worn into the original surface (Figure 2, E). Delamination was noted in 10 of the 78 glenoids, consistent with a fatigue wear mechanism (Figure 2, F). Seven components had fractured, including all 3 Hylamer glenoids (Figure 2, G).

Whether cemented or fixed with screws, metal-backed glenoid components provided a source of metallic debris that served as third-body debris, having become embedded into the polyethylene bearing surface. The 4 glenoids with metal backing fixed with screws all had embedded third-body metallic debris (Figure 2, H). All of the metal backed glenoid components had conforming surfaces.

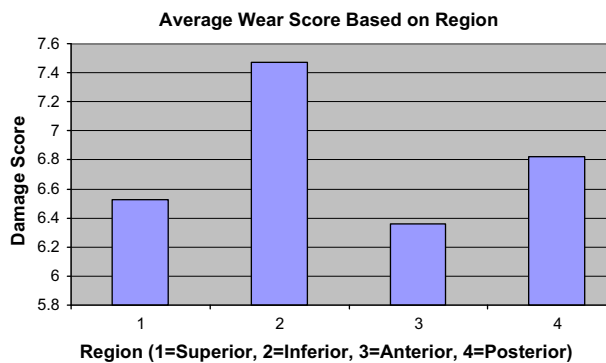
**Figure 3** Regional damage score regardless of mechanism.**A** Comparison of AP radiolucency based on zone of involvement

Irrespective of damage mode, the inferior glenoid sustained the greatest wear, with a mean total score of 7.5, and

the posterior region also had marked wear, with a score of 6.8 (Figure 3). The difference between inferior and posterior wear was statistically significant ( $P = .026$ ). The pattern of wear did not differ between conforming and nonconforming designs. When glenoid components with edge deformation were compared with those with impingement, edge deformation components had the greatest amount of wear posteriorly (mean score, 6.3), whereas components with impingement were most damaged inferiorly (mean score, 8.0). No correlation was found between patient age at the time of revision, length of implantation, or preresion range of motion with overall glenoid wear.

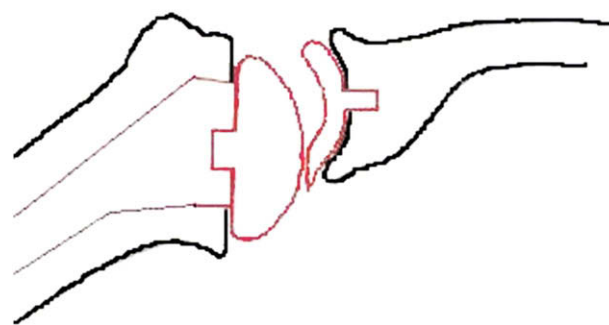
**Figure 6** Mechanism of rim deformation and eccentric loading.

In addition, adherence to these principles will decrease the risk of eccentric loading and subsequent edge deformation, which also has an important effect in glenoid loosening. Of the 18 components showing edge deformation, 16 were revised for loosening and 1 for anterior–superior subluxation of the humeral head. The mechanism by which edge loading leads to component loosening has been described as the rocking horse phenomenon and has been considered the primary cause of glenoid loosening.<sup>13</sup> As the prosthetic humeral head translates inferiorly and superiorly during motion, eccentric forces are produced on the glenoid rim, ultimately causing rim deformation and component loosening (Figure 6). However, of the 18 glenoid components with edge deformation, 83% were non-conforming glenoids with deformation occurring in the inferior and posterior quadrants vs the inferior–superior direction typical of conforming glenoid designs.

The glenoid components with edge deformation were implanted in retroversion, consistent with the humeral head loading the posterior and inferior polyethylene edge, and causing increased anterior radiolucent lines on imaging. Instead of the superior–inferior rocking horse seen in rotator cuff deficiency,<sup>3</sup> a glenoid component see-saw pattern may occur from posterior to anterior rocking in cases with glenoid retroversion. Glenoid retroversion leads to decreased glenohumeral contact areas, increased contact pressures, and posterior eccentric loading, all of which increase stresses on the cement mantle and increase the risk of edge deformation and component loosening.<sup>6,15,24</sup> Thus, it is essential that components are positioned and soft tissue is tensioned appropriately so that loads across the
