A Biomechanical Analysis of Shoulder Stabilization, Part 2

Posteroinferior Glenohumeral Capsular Plication

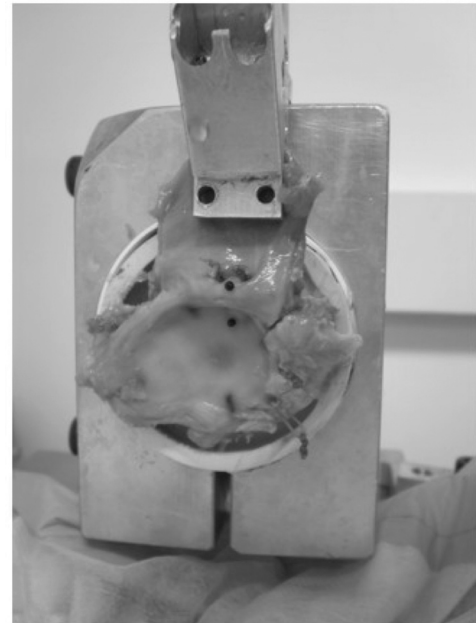
Figure 3. Specimen testing setup.

The specimen was then loaded into a materials testing system ([MTS] MTS Insight 5, MTS Systems Corp, Eden Prairie, Minnesota) for biomechanical testing. The potted glenoid was placed in a custom-made jig fixed to the platform of the MTS. The repaired PI quadrant was placed in a custom soft tissue clamp, attached to an in-line 1000-N load cell. The clamp gripped the specimen 1.5 cm above the marker on the labrum (again, verified with digital calipers to ensure consistency across specimens). The specimen was oriented such that the vector of labral translation force was directed from the glenoid in a PI direction (Figure 3). A 1 megapixel digital video camera was used to optically track the specimen markers throughout testing.¹¹ The recorded video (48 frames per second) was analyzed with Digital Motion Analysis Software (Spica Technology Corporation, Maui, Hawaii), which was synchronized to the force and actuator displacement data from the MTS software. On the basis of our calibration studies of marker displacements similar to those seen in the present study, the measurement precision and accuracy of our optical imaging system was 3 μm and 60 μm , respectively. Based on previous studies^{27,31} and our own pilot data, the following testing conditions were used for each specimen: preload at 5 N (constant load) for 2 minutes, followed by cyclical loading for 100 cycles from 5 to 25 N at 1 Hz, followed by pulling to failure load at 15 mm/min.

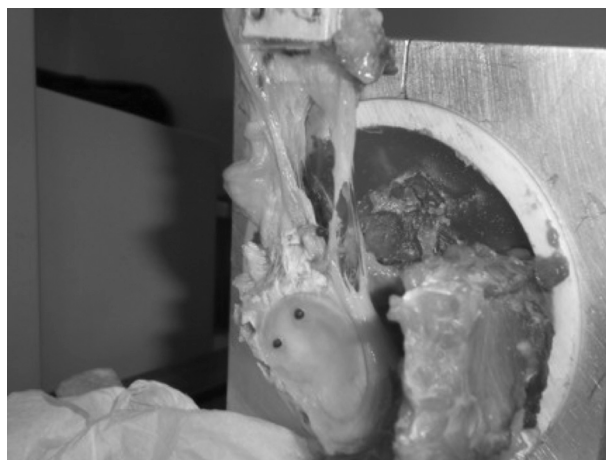
Figure 4. Glenolabral failure after pull-to-failure testing.

The modes of failure differed among the 3 groups, as shown in Figures 4 (glenolabral failure) and 5 (capsular rupture failure). In the simple stitch group, failure occurred by capsular rupture outside the construct, between the clamp and the stitch in 4 specimens (57.1%) and by tearing at the glenolabral junction in 3 specimens (42.9%). In the horizontal mattress group, failure occurred at the glenolabral junction in 6 specimens (85.7%) whereas a single specimen failed by capsular rupture (14.3%). In
