A Biomechanical Analysis of Shoulder Stabilization, Part 2

Posteroinferior Glenohumeral Capsular Plication

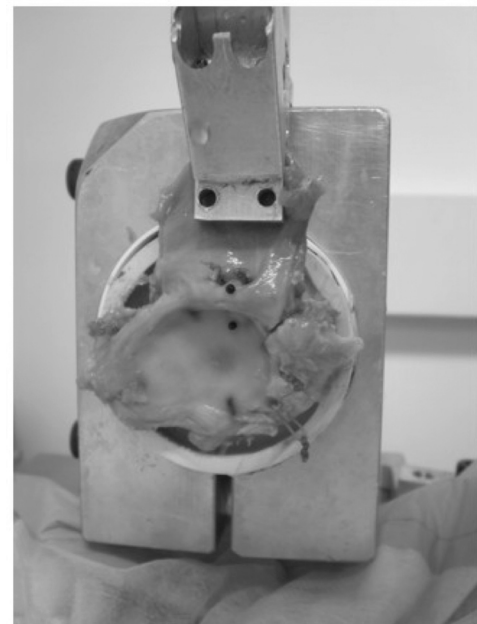
Figure 3. Specimen testing setup.

The specimen was then loaded into a materials testing system ([MTS] MTS Insight 5, MTS Systems Corp, Eden Prairie, Minnesota) for biomechanical testing. The potted glenoid was placed in a custom-made jig fixed to the platform of the MTS. The repaired PI quadrant was placed in a custom soft tissue clamp, attached to an in-line 1000-N load cell. The clamp gripped the specimen 1.5 cm above the marker on the labrum (again, verified with digital calipers to ensure consistency across specimens). The specimen was oriented such that the vector of labral translation force was directed from the glenoid in a PI direction (Figure 3). A 1 megapixel digital video camera was used to optically track the specimen markers throughout testing.¹¹ The recorded video (48 frames per second) was analyzed with Digital Motion Analysis Software (Spica Technology Corporation, Maui, Hawaii), which was synchronized to the force and actuator displacement data from the MTS software. On the basis of our calibration studies of marker displacements similar to those seen in the present study, the measurement precision and accuracy of our optical imaging system was 3 μm and 60 μm , respectively. Based on previous studies^{27,31} and our own pilot data, the following testing conditions were used for each specimen: preload at 5 N (constant load) for 2 minutes, followed by cyclical loading for 100 cycles from 5 to 25 N at 1 Hz, followed by pulling to failure load at 15 mm/min.
